Conveyor Belt Rollers

Project: Conveyor Belt Drive Rollers

Category: Wear & Abrasion Protection

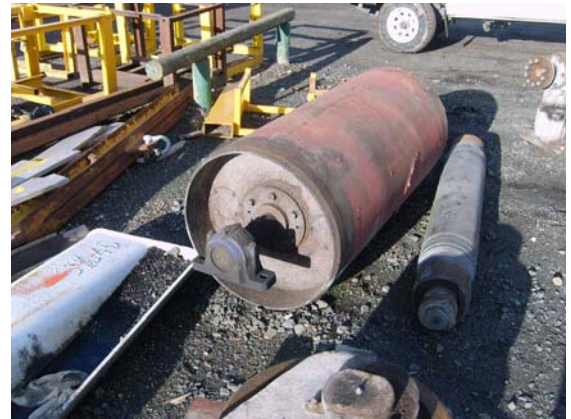
The Lining of this conveyer belt drive roller was eroded due to the abrasive nature of coal dust.

Before...

The old lagging was stripped off the roller and prepared for spraying. A 4mm thick guide coat of white Rhino Linings Duraspray was applied followed by a 6 to 8mm thick grey pigmented Rhino Linings Duraspray layer.

To complete the work a special jig was built enabling the rollers, sometimes weighing up to 5 tonne, to be sprayed and lished in one jig. This specially constructed jig enabled the Rhino Linings Dealer to lish the completed roller surface perfectly round following the spray application prior to giving the finished product back to the client.
