**Project:** Conveyor Belt

**Product:** Tuff Stuff

**Rhino Linings Dealer:** Mt Isa (Satin Touch)

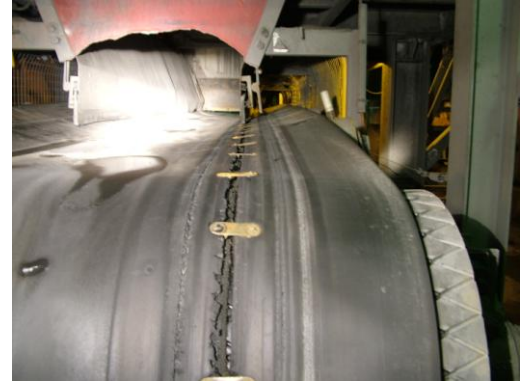
Before repair and with staples fitted

The belt is initially blasted with a high pressure water spray machine to dig into the rubber material of the belt, thereby removing dirt and 'scarifying' the surface. The tear is then held together with repair staples of a type suitable for the size of the tear.

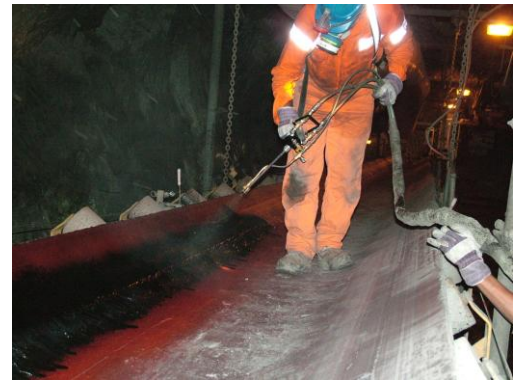
Application of Rhino Tuff Stuff (note overlap)

The Conveyor Belt is then primed with Rhino Linings premium polyurethane primer, RhinoPrime 251 (or epoxy primer RhinoPrime RL315), and the tear is then pour filled with Rhino TUFF STUFF<sup>®</sup>. Rhino TUFF STUFF is then spray applied over the filled tear to a reasonable thickness and span consistent with Rhino techniques. The thickness of the TUFF STUFF<sup>®</sup> lining is dependent upon the product being carried on the conveyor system and the expected time to the next shut down. This application is seen as a temporary repair system only, however, duration of operation can be quite extensive.

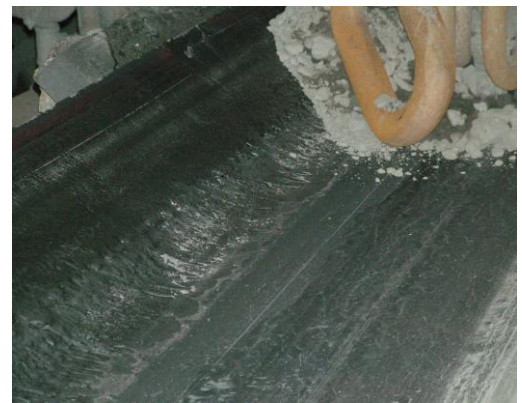
After repair and in operation
